**HUMAN ENGINEERING EVALUATION  
OF THE  
HYPERBARIC RESEARCH FACILITY  
(PHASE 1)**

**J.I. Brady and M.D. Curley**

**Naval Medical Research Institute**

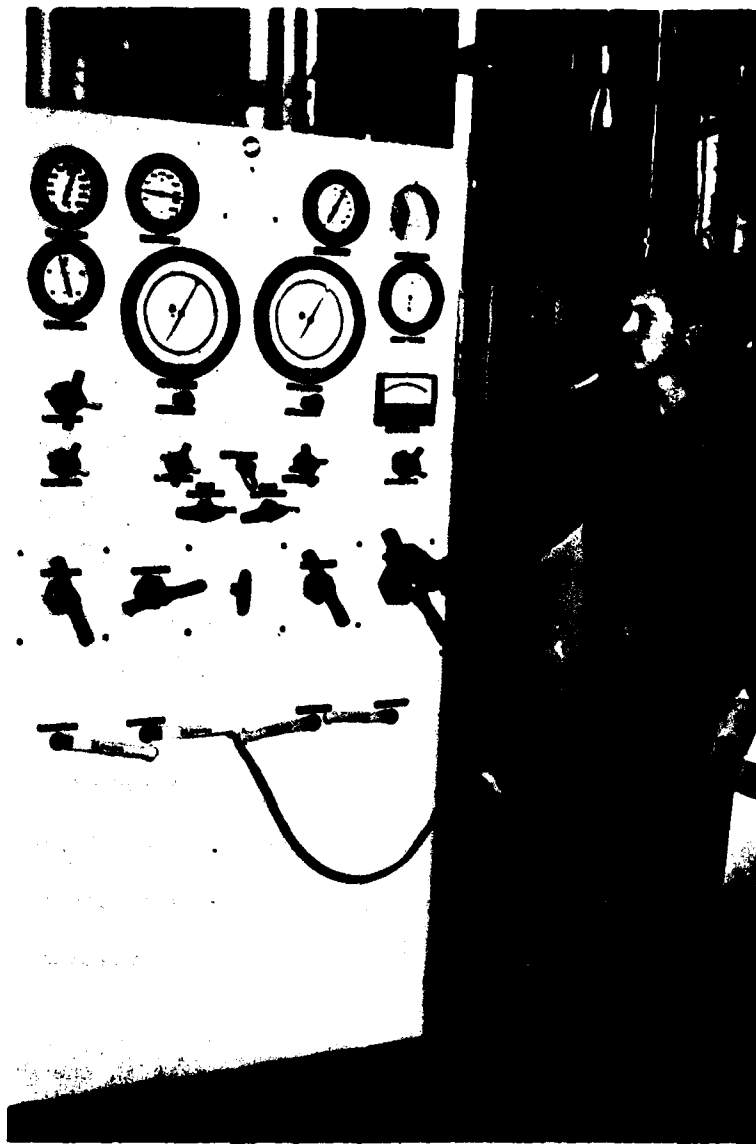
Fig. 8. Local panel with sound-powered phone cord amidst panel valving.

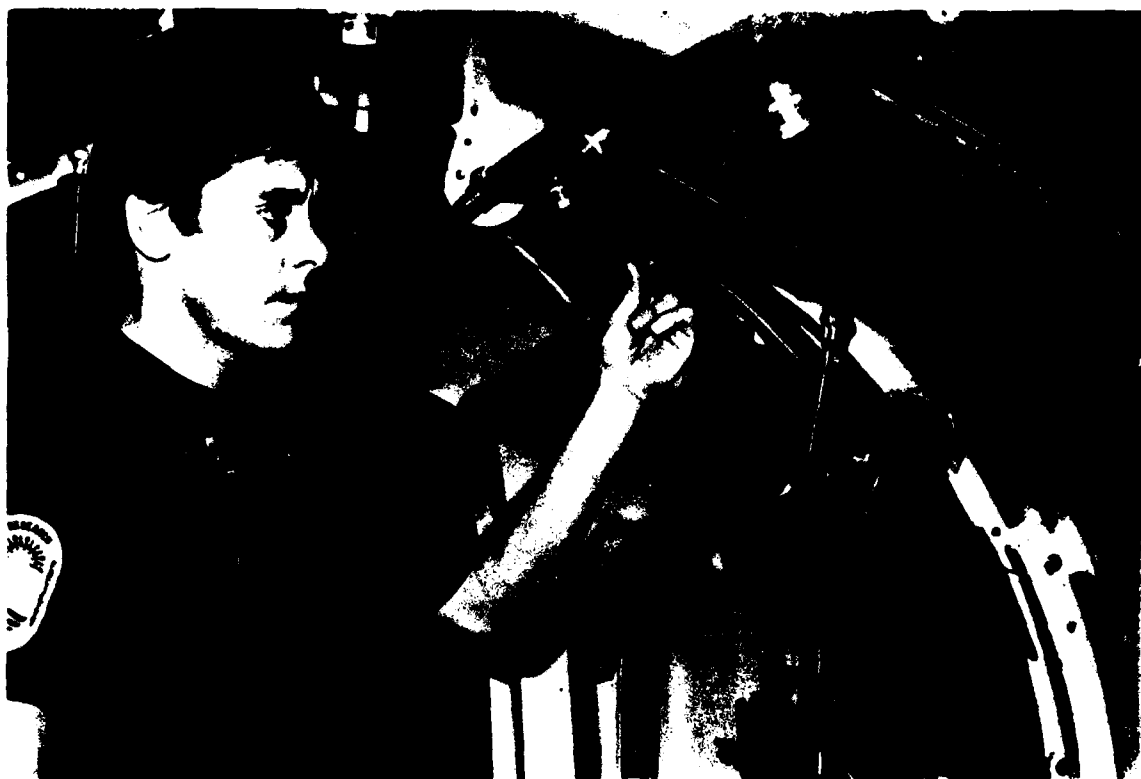
- modification of the FES pressure tracking system may be necessary if the problem is to be corrected. (Priority 1)
- (24) The design of the present FES lanyard pull inside the chamber may result in frequent inadvertent activations (Fig. 13). A lever or pushbutton design can still be operated quickly and yet would not lend itself to inadvertent operation. (Priority 2)

Fig. 13. Fire extinguishing system lanyard pull in D chamber. A pull on the cord activates the system causing a water spray to drench the chamber contents.

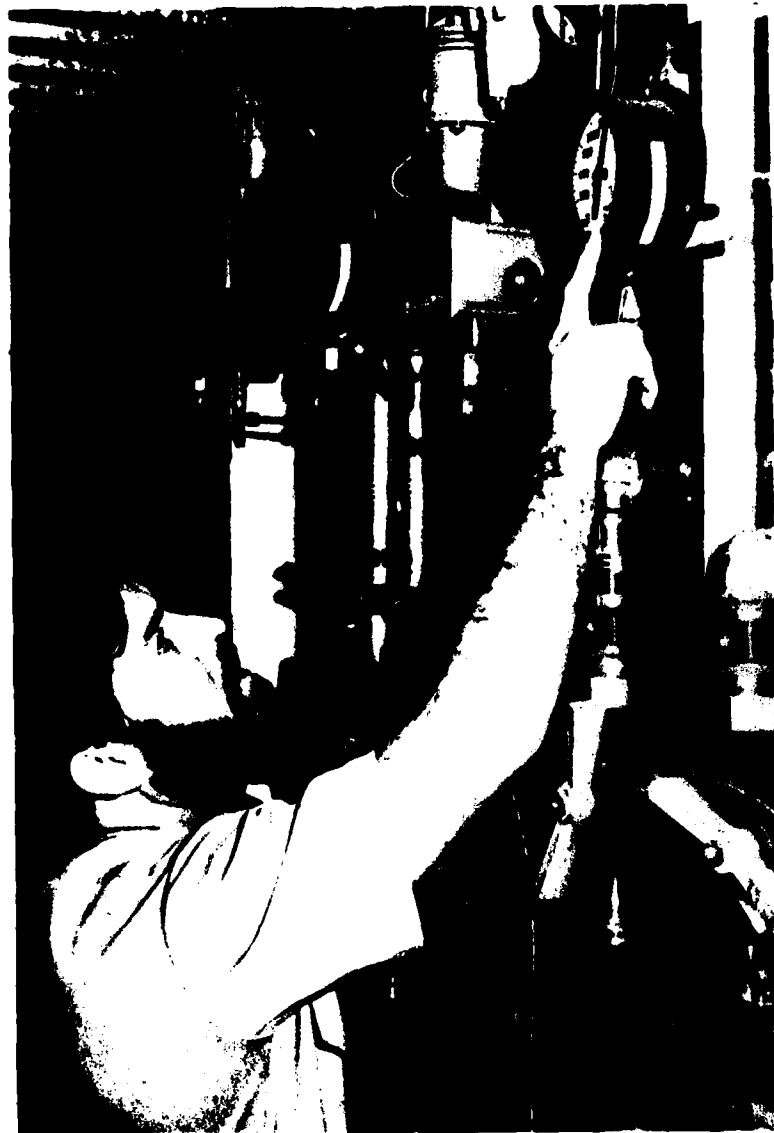
Fig. 14. Fifth percentile diver having difficulty reading bottlefield bank pressure gauge.

- (26) Bank pressure gauges in the bottlefield should be repositioned or at least tilted down for more efficient viewing (Fig. 14). (Priority 4)
- (27) A slightly elevated walkway (1-2 in.) through the bottlefield alleyway will provide better footing, easier access to some difficult to reach valves, and greater readability of the bank gauges (Fig. 15). However, it should not be so high as to cause head clearance problems with lights, etc. (Priority 4)

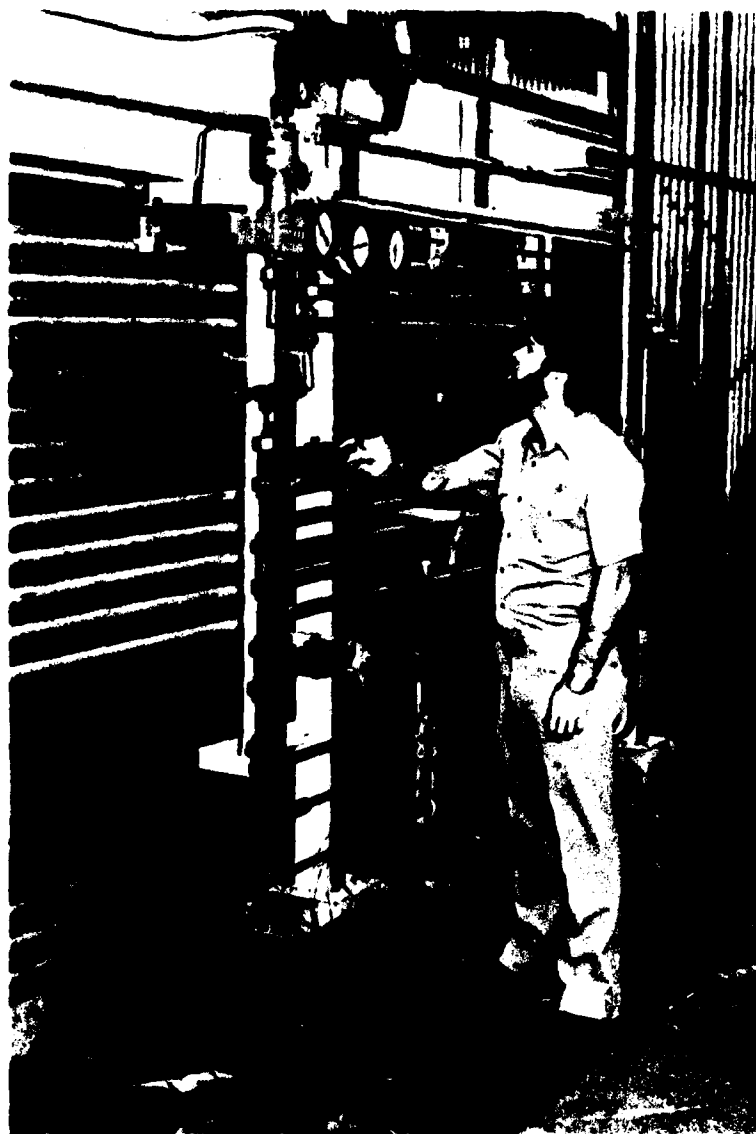
Fig. 16. Bottlefield oxygen regulators and valving are located outside and have no protection from inclement weather.

- (28) A protective roof or hood to shield the bottlefield oxygen regulators and their associated valves from ice and snow in the winter is recommended (Fig. 16). (Priority 2)

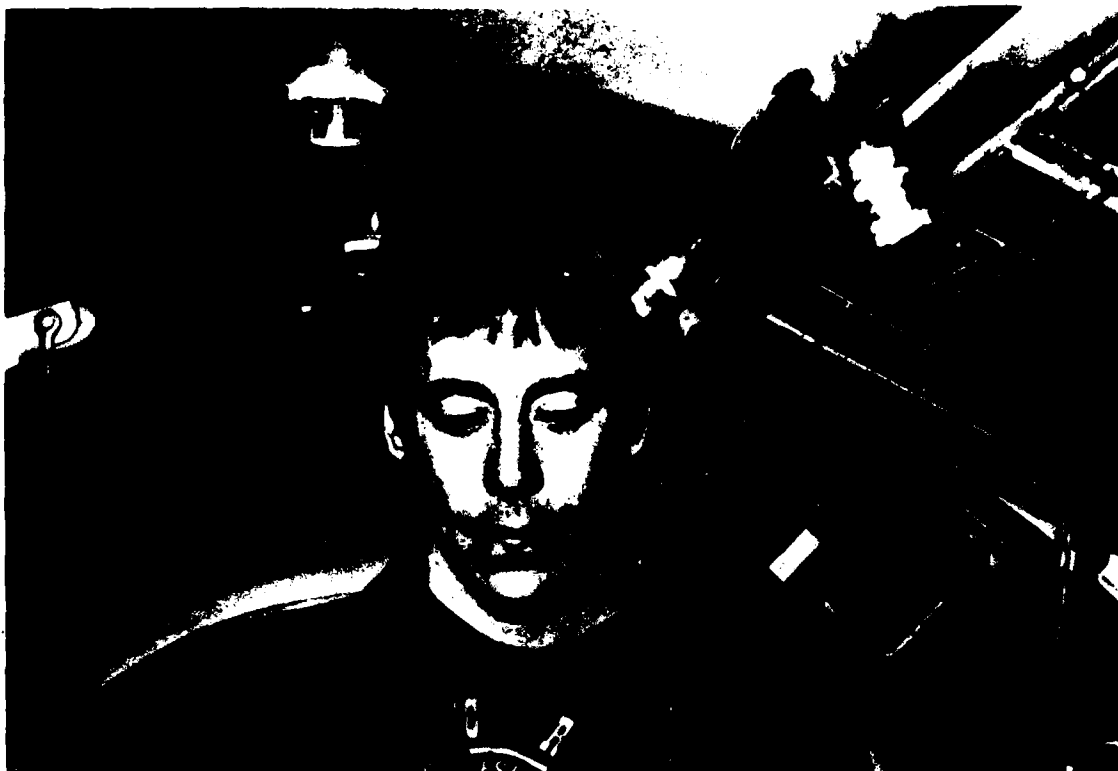
Fig. 17. Fire extinguishing system spray nozzles pose possible head impact problems for divers.

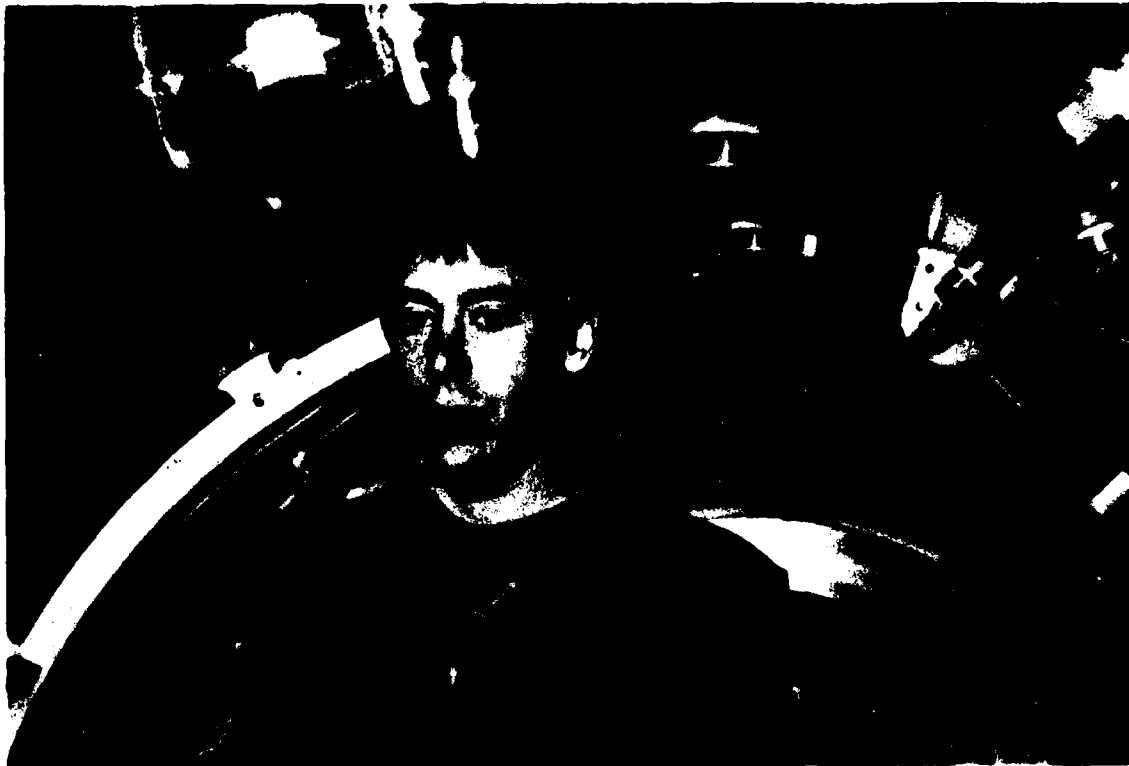
Fig. 18. Screened overhead penetrators pose head injury possibilities for divers over 71 in.

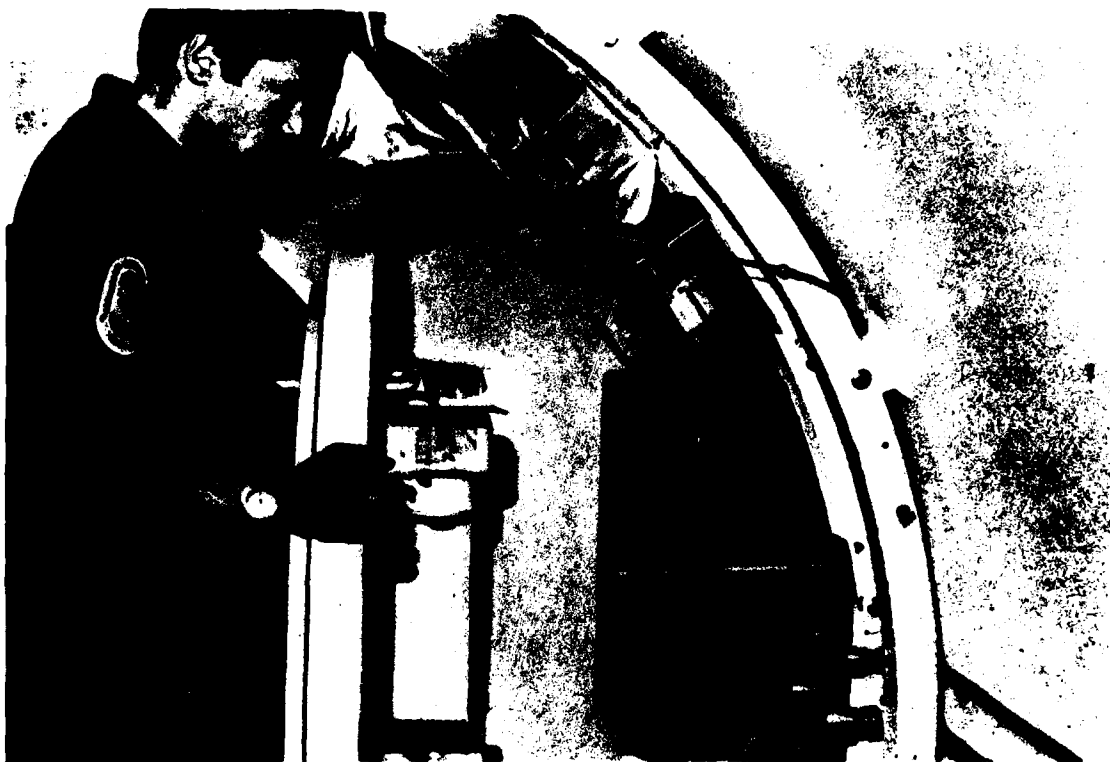
Fig. 20. Hatch opened in D chamber and obscuring the fold-down sink.

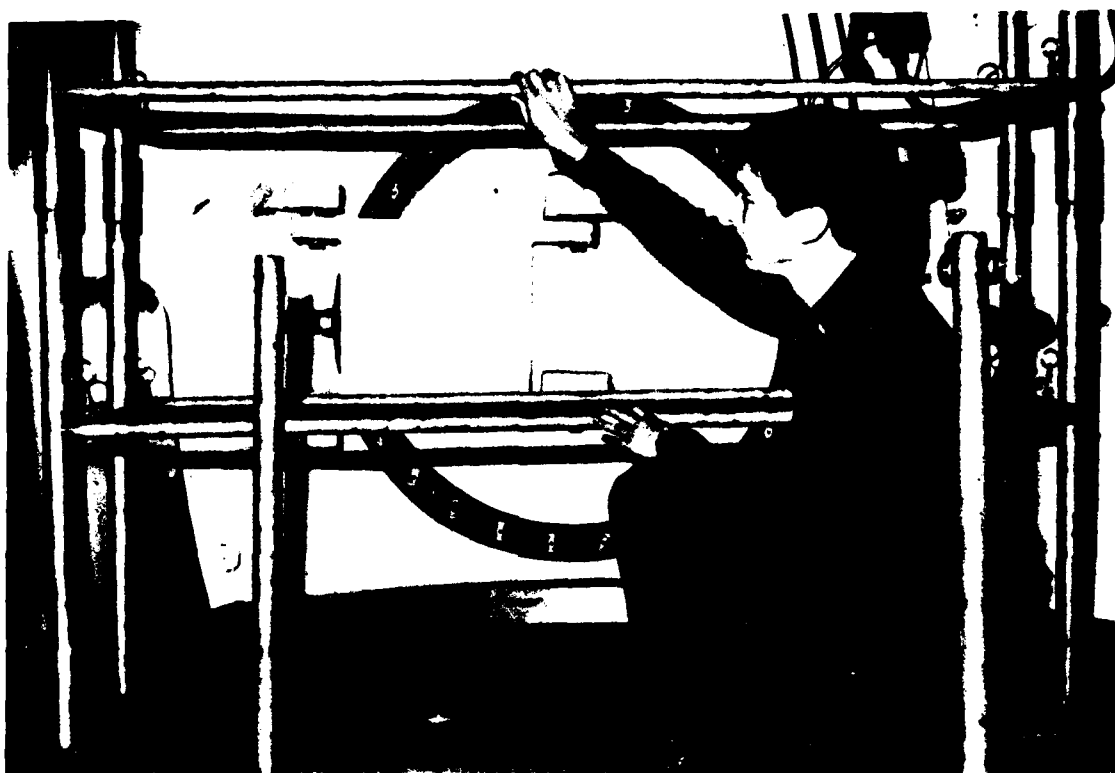
Fig. 23. Removable brackets for bunks in C chamber.

- (38) The removable bunks in C chamber (Fig. 23) should be moved to permanent locations in other chambers. See Fig. 24 for recommended locations. (Priority 2)

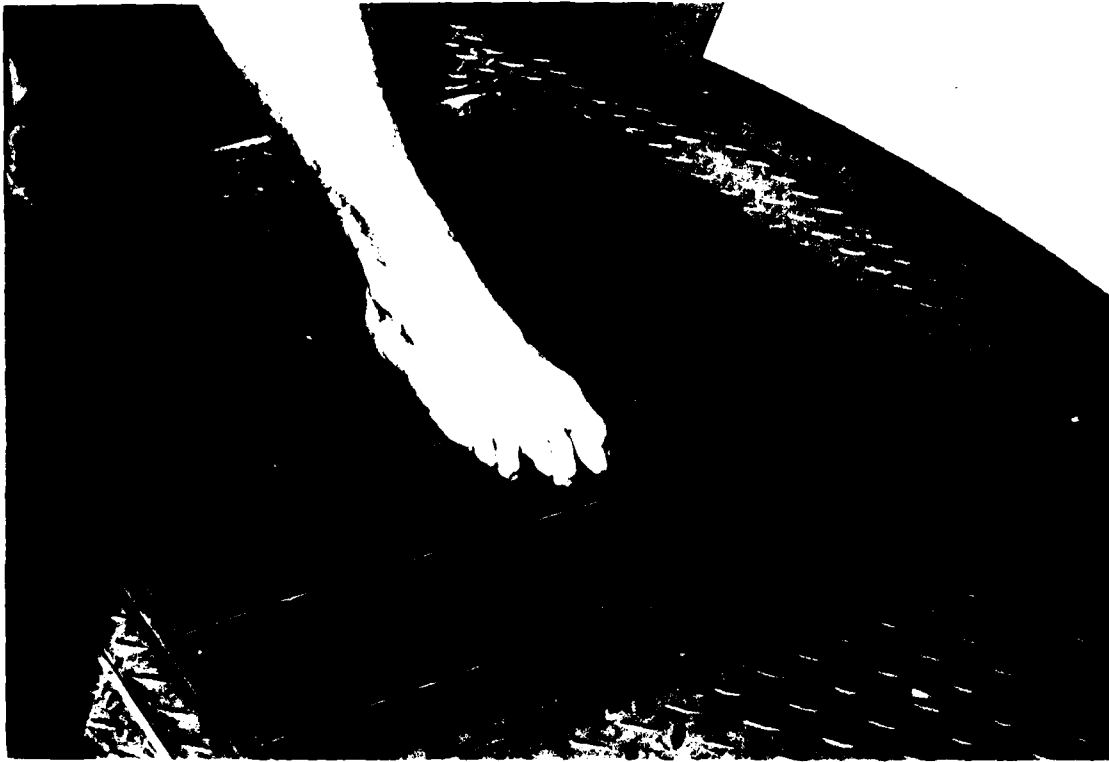
Fig. 26. Present design of shower deck plate. Note large gaps in mesh which could lead to toe and foot injuries.

- (43) The current grate on the deck in the shower (Fig. 26) should be replaced with a finer mesh design which will be more comfortable to the feet and less likely to produce toe and foot injuries. (Priority 3)

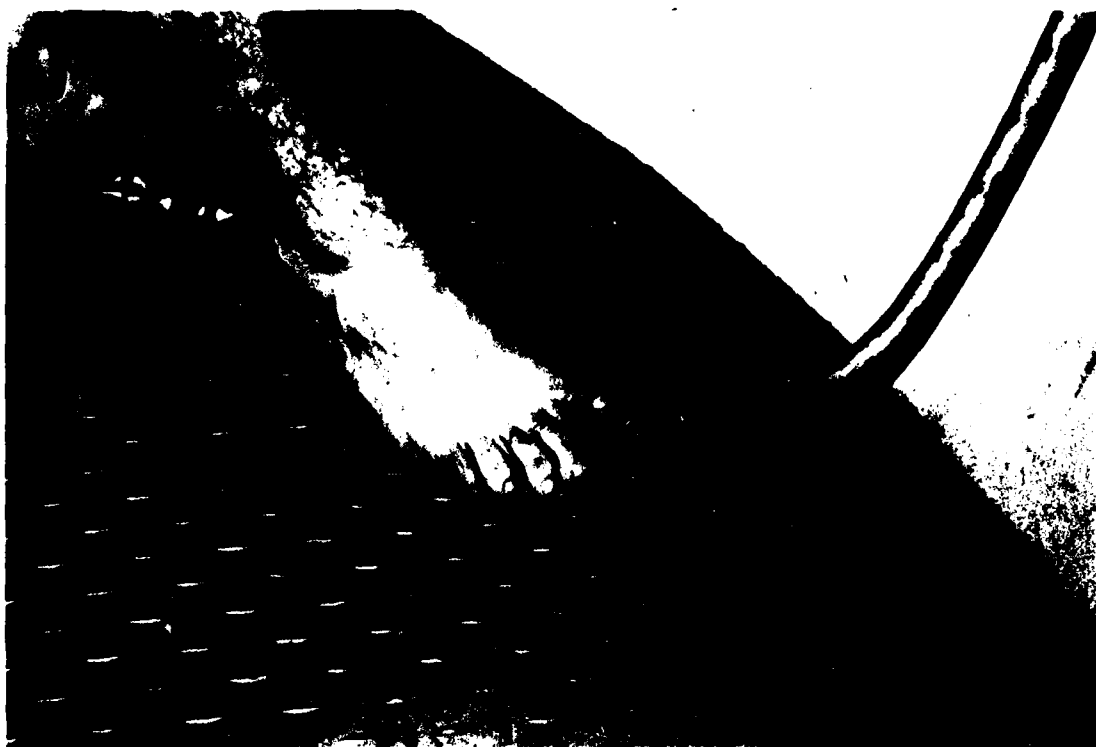
Fig. 27. Unpadded deck penetrator in C chamber which could produce toe and foot injuries.

- (44) It is recommended that a padded cover be added to the deck penetrator (Fig. 27) in C chamber to prevent foot contact injuries during diving operations. (Priority 3)

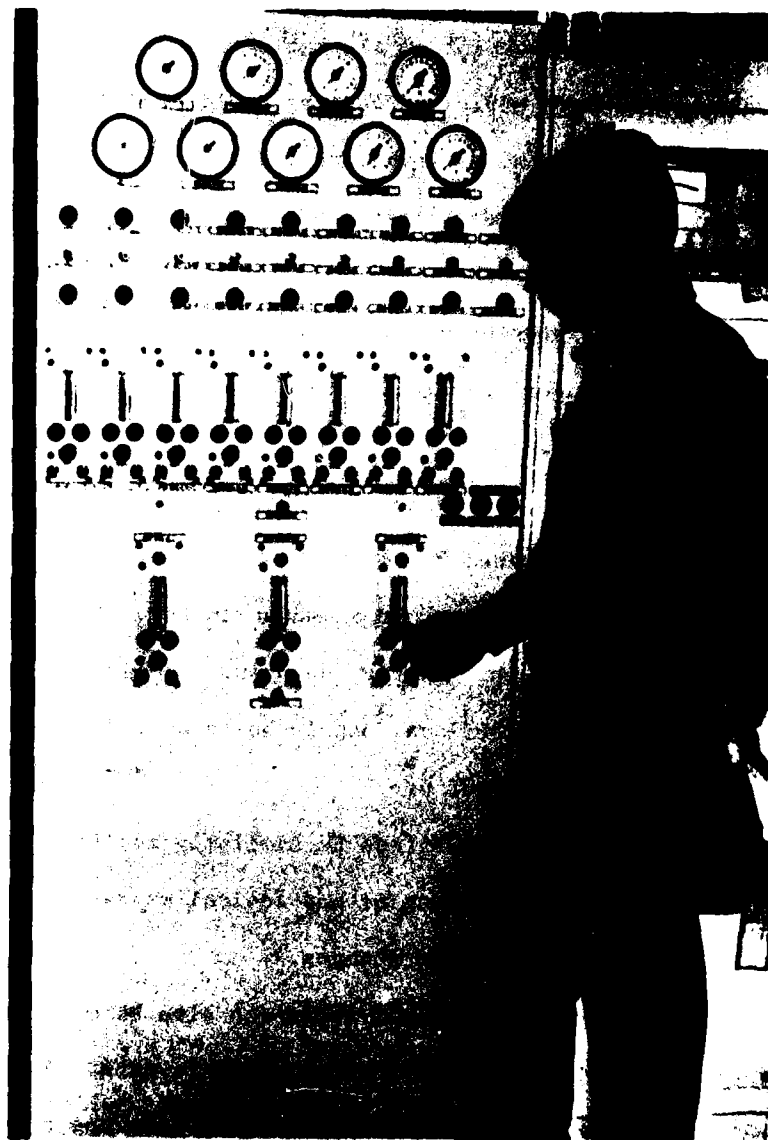
(52) Figure 28 shows the present design of the gas analysis patch panel. As can be seen, no attempt was made to group components by function or to color-code them in a manner to clarify their purpose to an

Fig. 28. Present design of the gas analysis patch panel.

operator. Figure 29 shows the recommended changes. This layout does not require the movement or alteration of any of the hardware (although several more efficient designs could be devised). It simply employs functional grouping and color coding. This design should improve operator recognition and readability while reducing errors. (Priority 2)

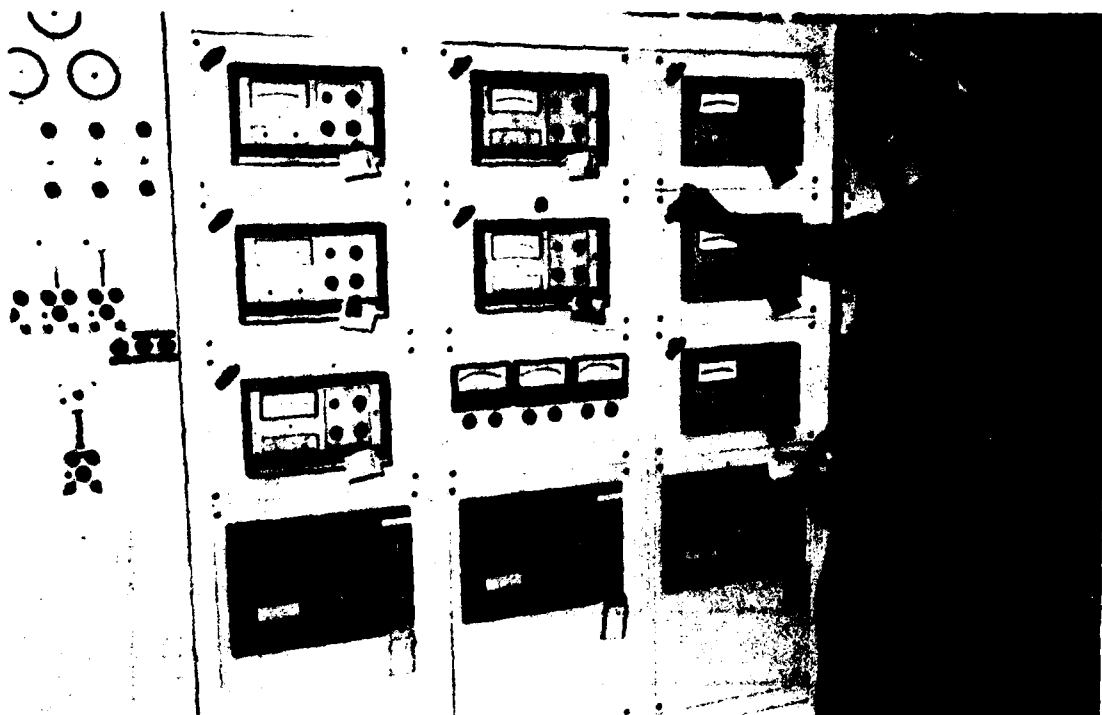
Fig. 30. Present design of gas analysis instrumentation panel.

- (53) Figure 30 shows the present gas analysis instrumentation panel. The recommended changes are similar to those above (see Fig. 31). (Priority 2)
- (54) Figure 8 showed the face of a local control panel. Greater clarity of function can be obtained by concise gas paths and simple noncoded labeling. The recommended scheme is shown in Fig. 32. (Priority 2)

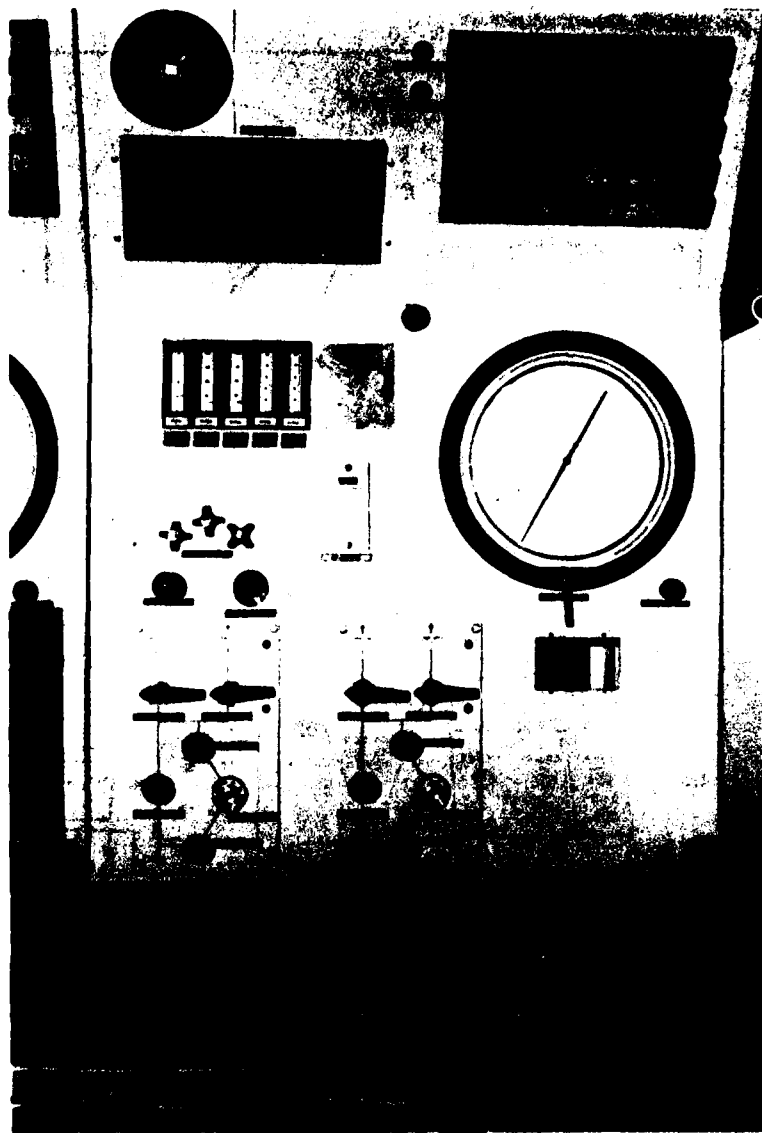
Fig. 33. Current configuration of a master console operating panel.

- (56) The operating panels (Fig. 33) can be similarly modified to improve their organization in a meaningful and logical manner. Figure 34 shows a layout for recommended changes. (Priority 2)
